2019 Wetland Report

Iron Horse Park Superfund Site: AOC 3

Billerica, Massachusetts

26 December 2019

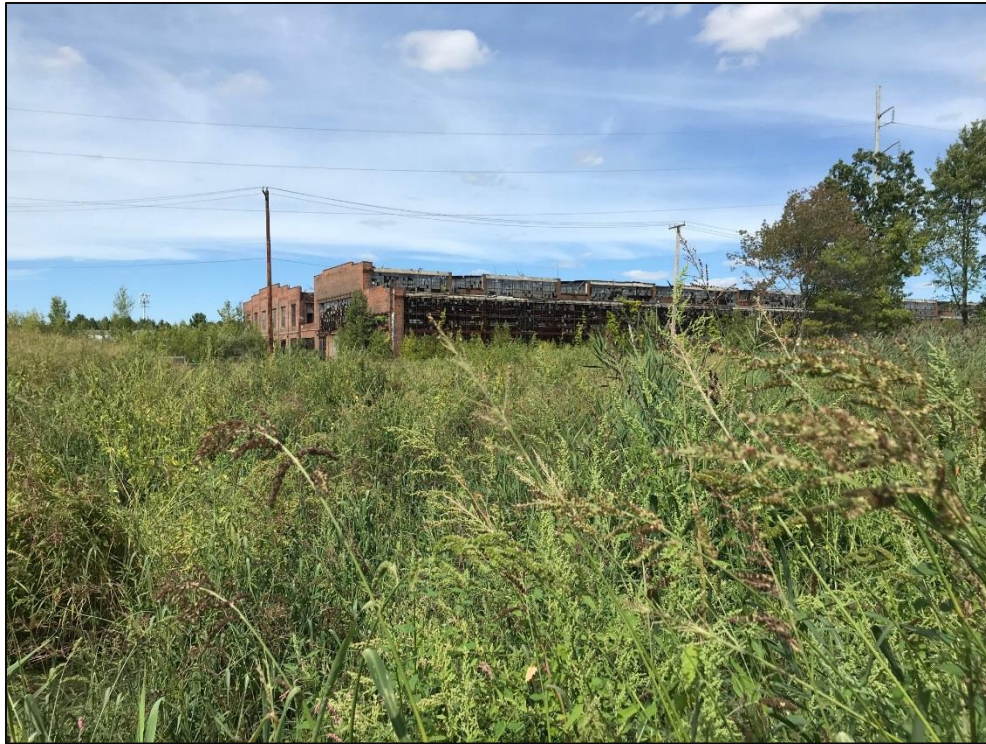
Photo Station 6 Facing North

As described in the Plan, the risk of colonization of invasive species is high, particularly purple loosestrife (*Lythrum salicaria*) and *phragmites* (*phragmites australis*; also called common reed). In the surrounding areas of the Site, east of photo station 6, ERM observed large concentrations of *phragmites*. A berm on the outer edge of the wetland appeared to function as a barrier, reducing the spread of *phragmites* into the restored wetland. Around the eastern edge of the Site, scattered patches of *phragmites* were observed. ERM did not observe *phragmites* in other areas of the restored wetland. Bordering the riprap along the southern portion of the Site, isolated stems of purple loosestrife (less than 10 individuals) were observed. In addition, one stem of purple loosestrife was observed in plot 2B, but composed less than 1 percent of the herbaceous stratum. ERM identified one stem of black locust (*Robinia pseudoacacia*) in plot 2B.

To control the extent of invasive species, ERM supervised herbicide treatments/applications. SWCA Environmental Consultants (SWCA) performed one application on 6 September 2019. Two SWCA technicians, equipped with backpack sprayers, spot treated the invasive species observed on the Site. In total, SWCA applied 8 gallons of mixed herbicide containing glyphosate, non-ionic surfactant, and marking dye. To prevent invasive species from outcompeting native species. ERM recommends an application in late summer 2020 (Year 2).
